Manhole Inspection Summary

Manhole # S41U__023MH

Insp Date: **10/9/08 11:46 AM**

Location Address: **900 e fort ave**

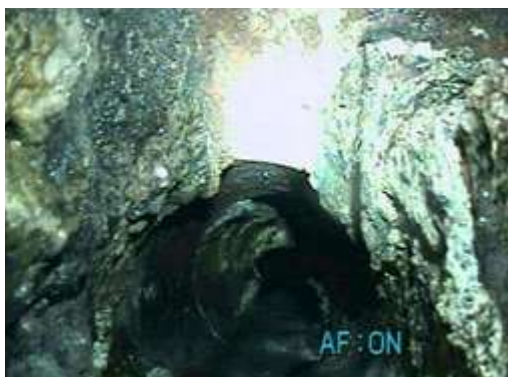
Defect 4

Condition: ☐ Sound ☐ Cracked ☐ Root Intrusion ☒ **Deteriorated** ☐ Leaks ☒ **Debris**

channel deteriorated, channel debris

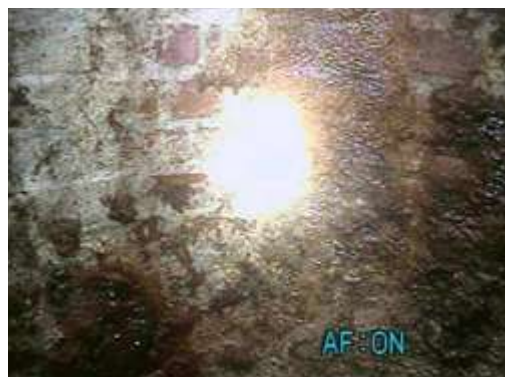
Defect 3

Infiltration: ☐ None ☐ Joint ☐ Cracks ☐ Mortar ☐ Roots ☒ **Wall**

barrel wall infiltration

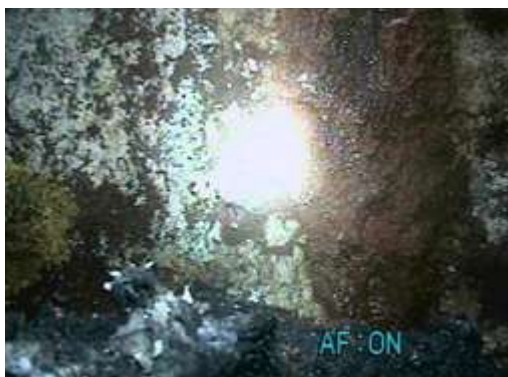
Defect 2

Condition: ☐ Sound ☐ Cracked ☐ Root Intrusion ☐ Deteriorated ☐ Leaks ☒ **Debris**

bench debris

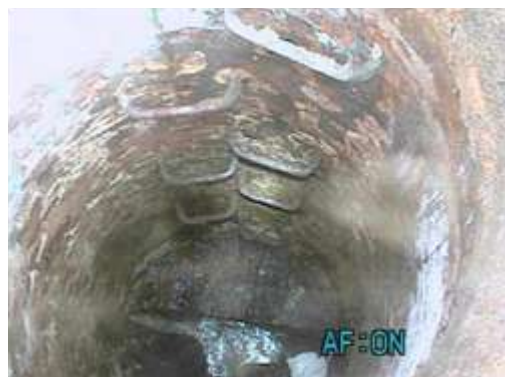
Defect 1

Count: **7** Missing: **0** ☒ **Corroded**

☒ **Evidence Of Surcharge** Depth: **4** (ft.) ☐ Active Surcharge Present

corroded steps, surcharge evidence

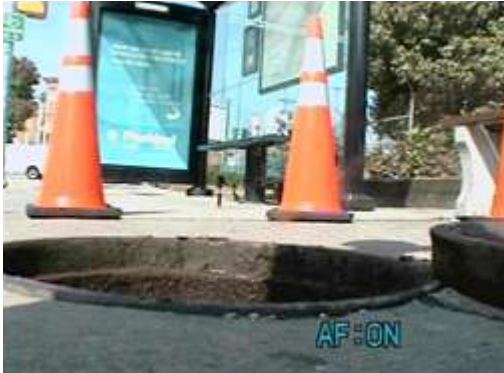
Defect 5

Diameter: **26** (in.) Length: **0** (in.) Dist A/B Grade: **1** (in.)

cover to grade
